# CENTER FOR INFRASTRUCTURE ENGINEERING STUDIES

## Strengthening of Masonry Elements with FRP Composites

*University of Missouri-Rolla*  
Antonio Morbin, Visiting Scholar

**CIES**  
**02-23**

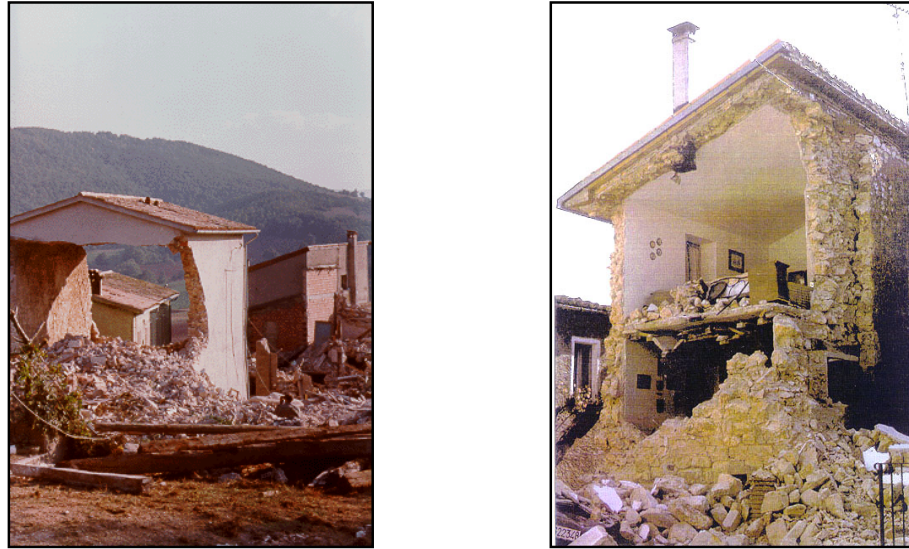
Seismic loadings induce *out-of-plane* bending of walls between the restraining floors. Analysis of the failure modes must take into account many different factors, such as boundary conditions, wall compressive strengths, joint tensile strengths, wall stiffness, and applied loadings. Walls will typically remain stable under dead load and after cracking if they are within the specified height-to-thickness ratio. In the slenderness ratio is exceeded, the wall needs bracing by either a horizontal brace or vertical columns. Parapets, chimneys, and similar elements extending above the topmost line of restraint are most vulnerable to out-of-plane forces.

**Fig.1.1.1 a-b** *Out-of-plane collapse of bearing walls*  
Umbria, Italy, 1997

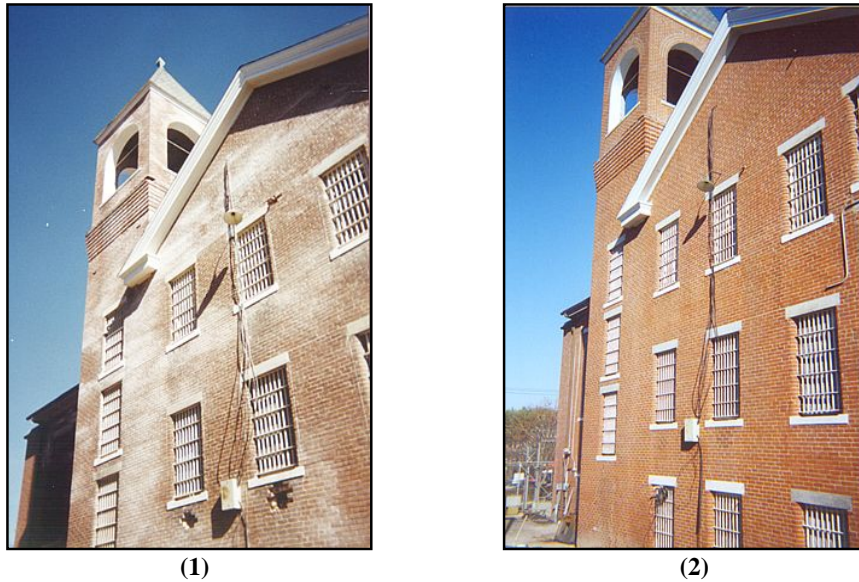
A common practice is to hose down the wall about one hour before repointing to remove debris and to wet masonry units. The fresh mortar, matching the original material as closely as possible, is placed in layers and tooled when thumb print hard. The new mortar should match as closely as possible the existing mortar in color, texture, and physical properties. In major restoration projects of historic buildings, comprehensive investigations may be justified to ensure the compatibility and long term durability of the repaired joints (see Fig. 1.2.2.1).

Fig. 1.2.2.1 A masonry facade before (1) and after (2) a repointing application

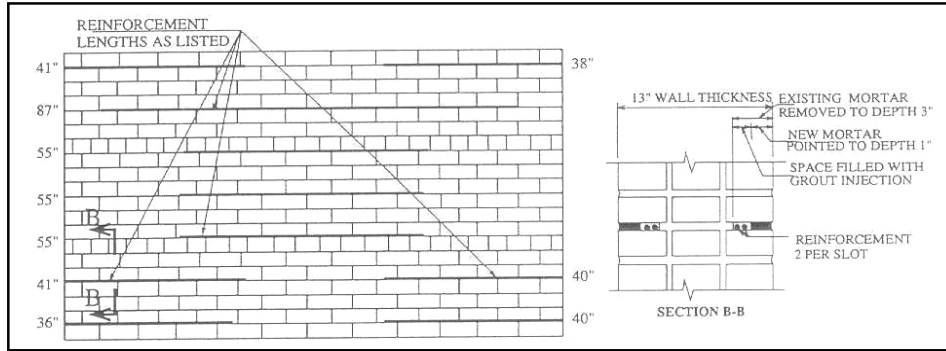
*Manzouri et.al.* (1996) evaluated the efficiency of repairing URM walls by grout injection in combination with horizontal and vertical steel reinforcement. URM walls were built in three whites with clay bricks for an overall dimension of 8 ft.-6 in by 5 ft. The walls were tested under in-plane loading. First, the behavior of the walls in their original condition was investigated. Then, the walls were retrofitted to be tested once again. All the retrofitted walls were injected with grout. The severely damaged areas were repaired by replacement with similar materials. Crack widths larger than 0.06 in were injected with a coarse aggregate; whereas, crack widths ranging between 0.008 to 0.06 in. were injected with a fine grout. Steel ties for use as dry-fix remedial anchor were placed as vertical reinforcement used for the pinning of the wythes in the toe area; and horizontal reinforcement as can be observed in Fig. 1.2.2.5a. The ties were made of Type 304 stainless steel with a helical design, similar to a self-tapping screw, which cuts a spiral groove as it is tapped into a pilot hole. The installation procedure included cutting of certain bed joints to a depth of 3-in. followed by placement of the tie in the slot and sealing with mortar.

**Fig. 1.2.2.5a Location of Horizontal Reinforcement-Internal Steel Reinforcing**

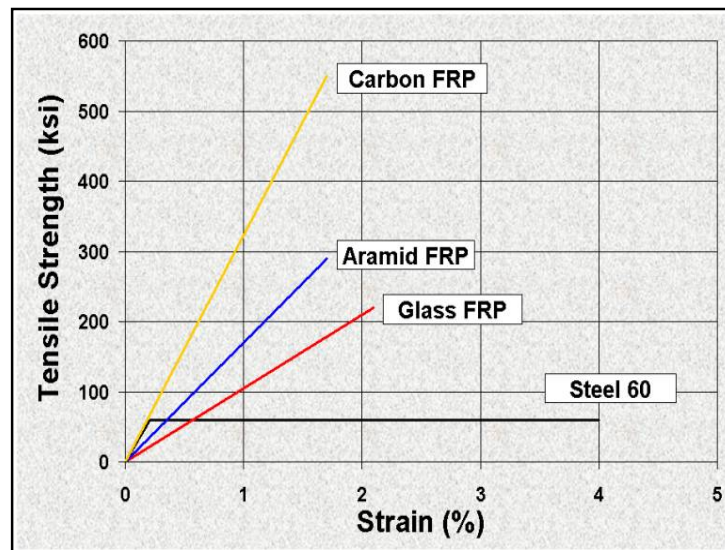
A comparison based on fiber area only among sheets made of carbon (CFRP), aramid (AFRP), glass (GFRP) and reinforcing steel in terms of stress-strain relationship is illustrated in figure 1.3.3c:

Fig. 1.3.3c Comparison among AFRP, CFRP, GFRP and Steel

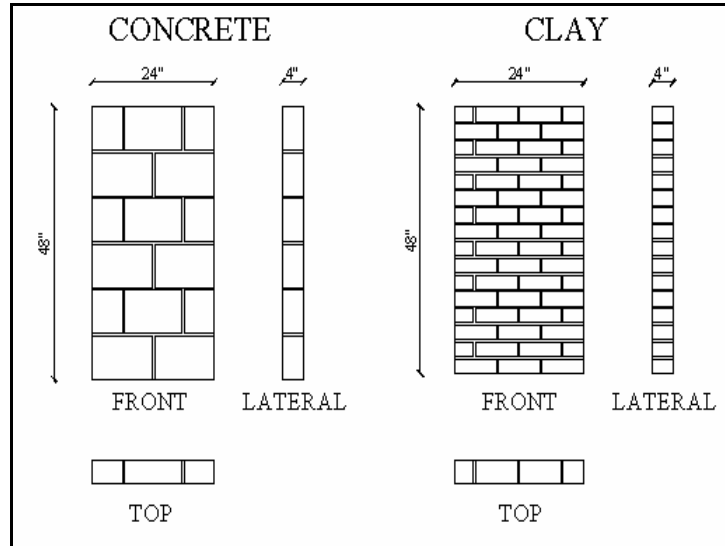
**Fig. 2.3.1c URM wall patterns**

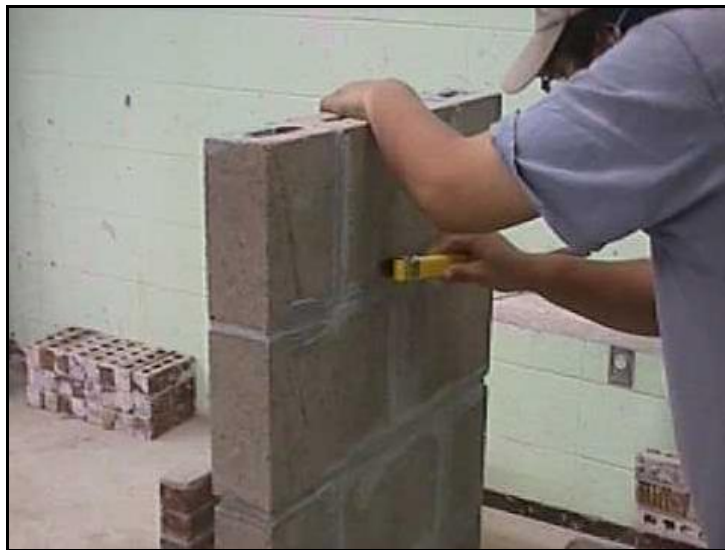
The wall is first cleaned with a steel brush (Fig. 2.3.3a), then dust and any loose particles are removed with high air pressure (Fig. 2.3.3b). A thin layer of primer is coated to the wall surface where the composite strips are to be attached (Fig. 2.3.3c). The surface of the walls, particularly at the joints, is leveled with putty (Fig. 2.3.3d). A first coat of saturant is applied on the surface (Fig. 2.3.3e); next, the composite strips are cut to size (Fig. 2.3.3f) and bonded to the wall face by hand pressure (Fig. 2.3.3g) and pressed with a roller to eliminate air bubbles (Fig. 2.3.3h) and to ensure that the fabric is saturated with the saturant. Finally, the exterior surface of the fabric is coated with a small layer of saturant for protection and instrumentation purposes. In the following pictures all the steps previously described are illustrated.

**Fig. 2.3.3a** *Cleaning of the wallettes with a steel brush*

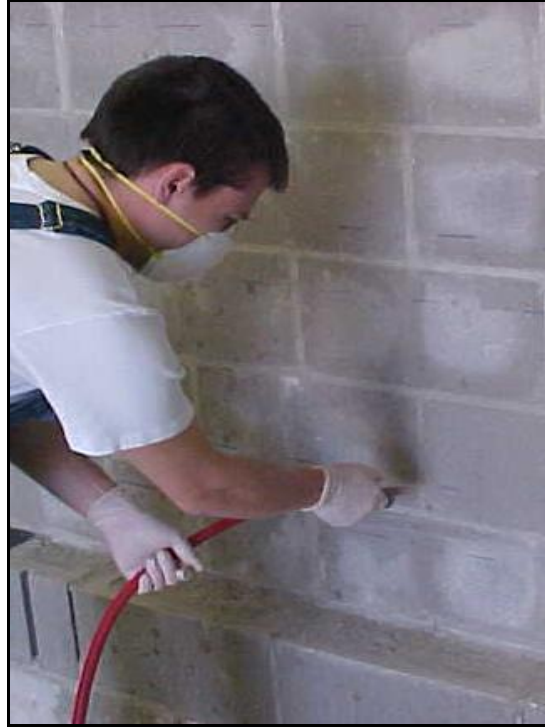
**Fig. 2.3.3b** *Removing of dust and any loose particles*

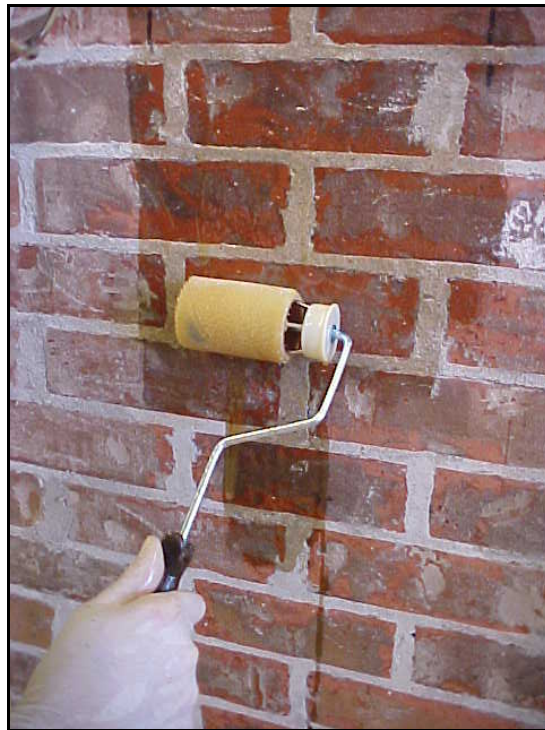
**Fig. 2.3.3c** *Application of primer on clay*

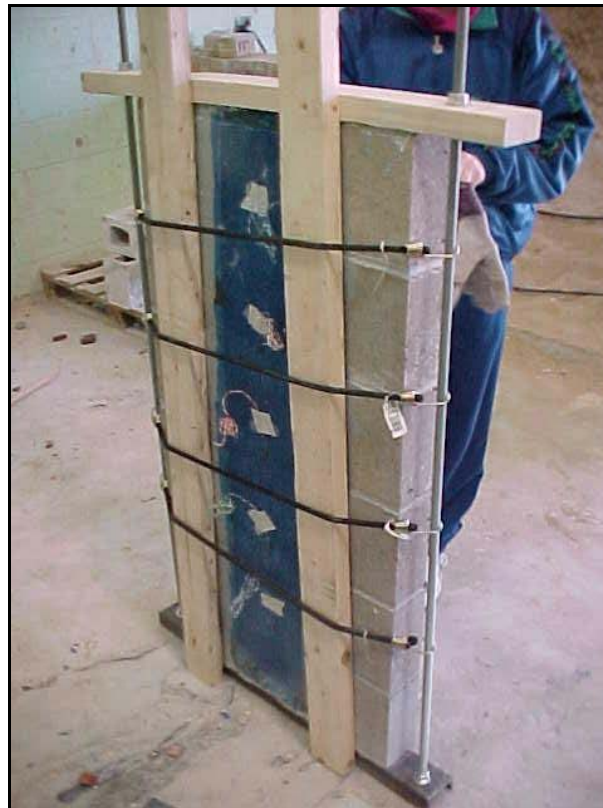
Fig. 2.3.4f Reinforced specimen before testing

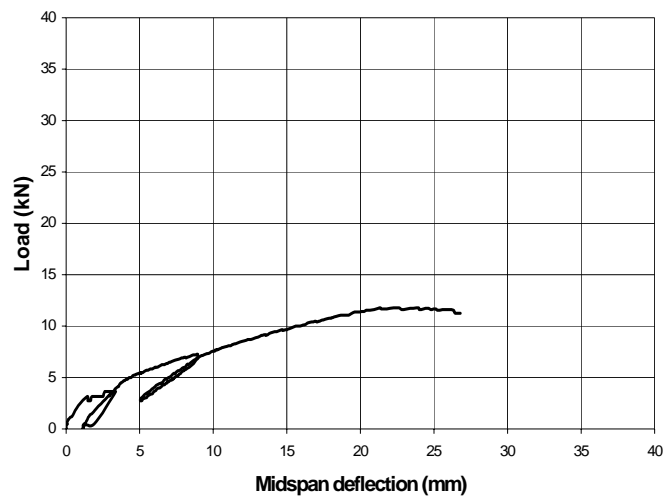
A specimens with same characteristics of the previous one was investigated. The first visible crack was observed at a load of 2.2 kN, running along the middle mortar joint, for the entire length. The peak load was reached at 11.84 kN, 30% higher than the first one, for a midspan deflection of 26.81 mm, as shown in Fig. 2.3.5d. The failure, similar to that observed in COG3, was caused by a debonding effect which involved in this case not only the FRP reinforcement but the concrete unit surfaces either. Therefore in this case the failure mode should be identified as a combination of debonding and peeling of concrete. The increase of the peak load should be attribute to a better bond between the concrete surface and the FRP laminate, which means a better penetration of primer and saturant into the porous surface of the bricks. Strain channels revealed that at mid-height FRP laminate reached a strain value of 1.5 % before delamination occurred.

Fig. 2.3.5d Load vs. Midspan net deflection Curve-Wall COG3R

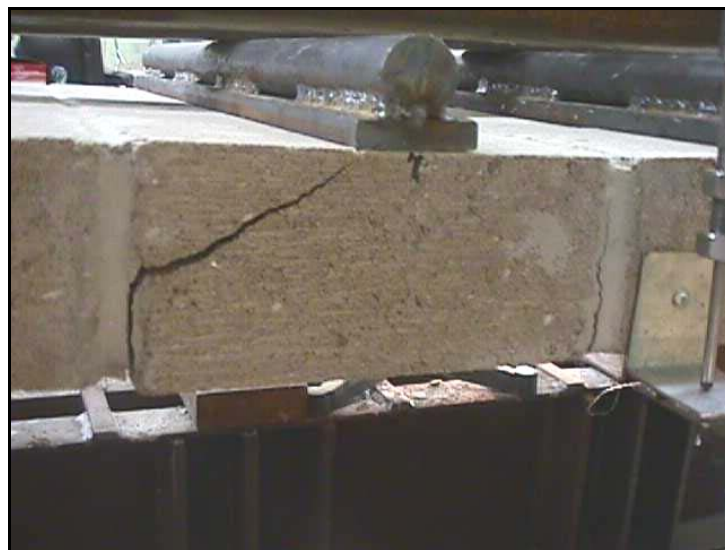
**Fig. 2.3.5f Developing of flexural-shear crack under a loading point**

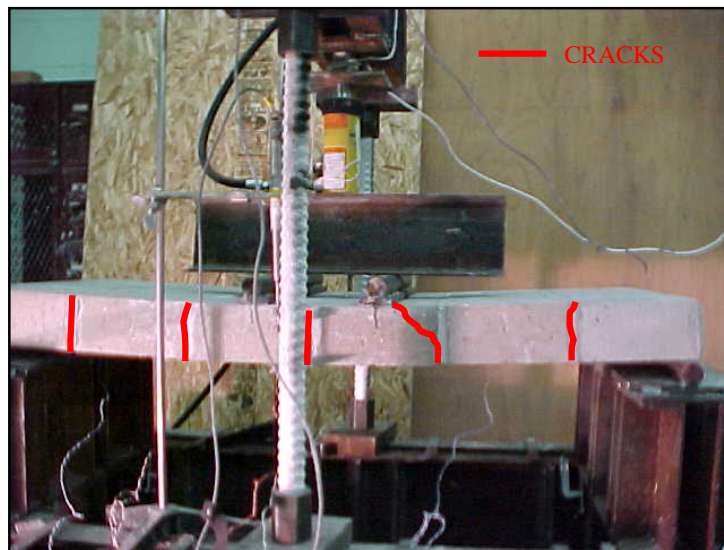
Fig. 2.3.5l Crack patterns at the ultimate stage

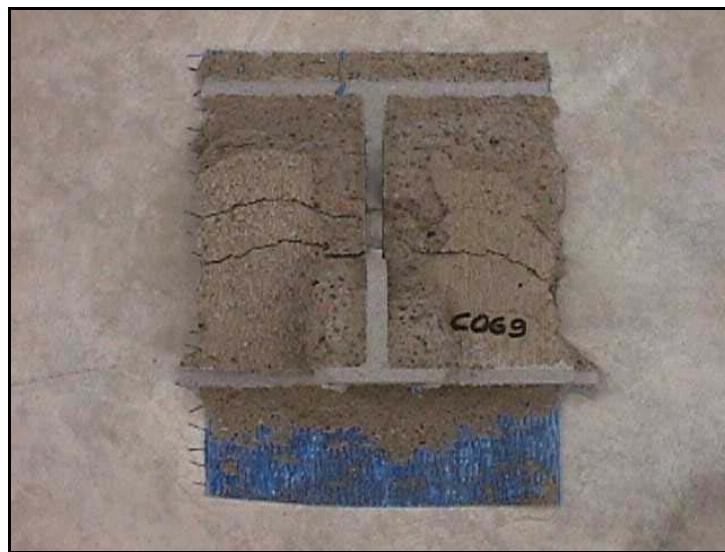
Fig. 2.3.5n FRP sheet sample after failure

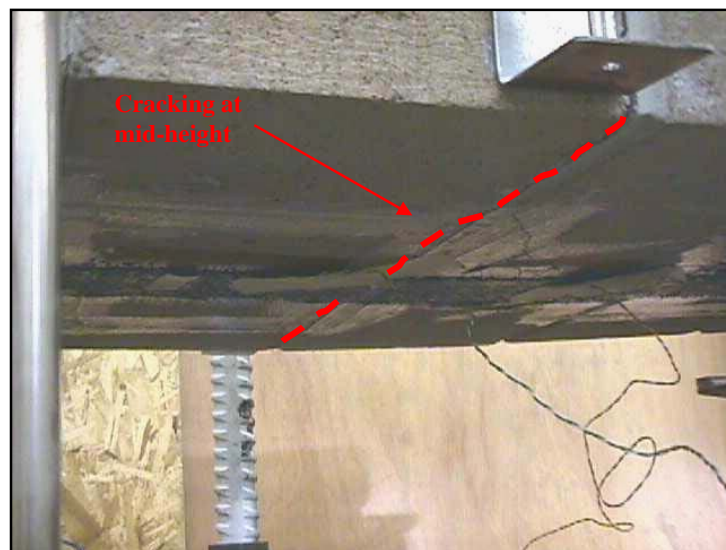
**Fig. 2.3.5b\*** Major horizontal crack at mid-height

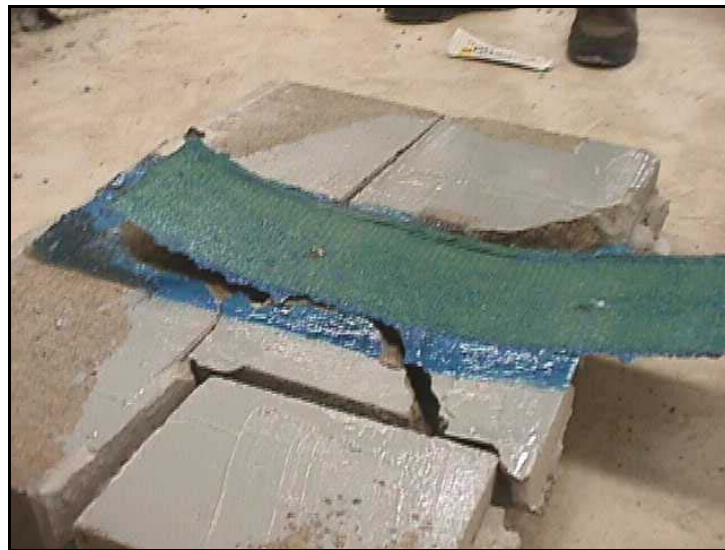
Fig. 2.3.5d\* Edge of the specimen after debonding failure

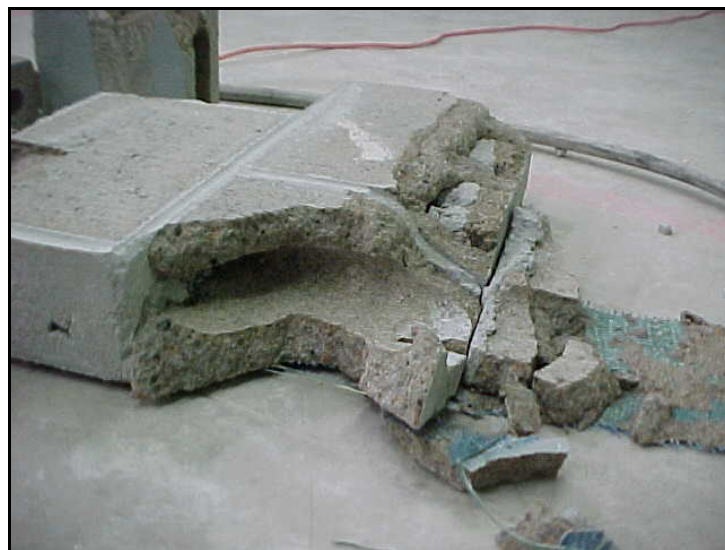
Fig. 2.3.5f\* 45° fractures in concrete units

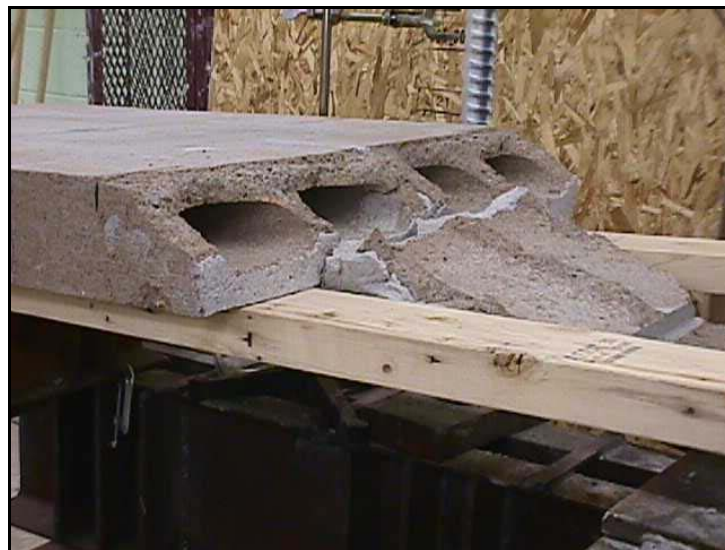
Fig. 2.3.5h\* Shear fractures on masonry units

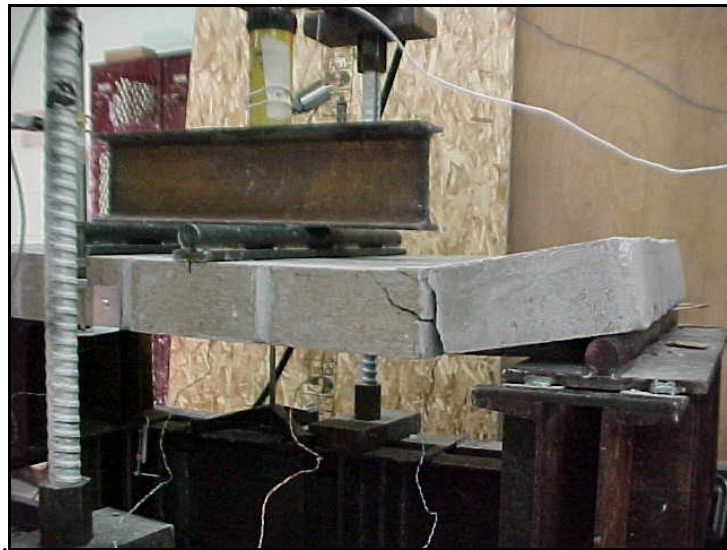
No differences were observed in terms of mechanical behavior compared to COA9. However, a larger presence of cracks spread for all the mortar joints were detected. The maximum load was registered at 26.98 kN for a midspan deflection of 15 mm; the big difference with COG9 was that the failure was caused by the shear collapse of the concrete units located at the edge of the specimen, as shown in Fig. 2.3.5i\*.

**Fig. 2.3.5i\*** *Failure at the edge*

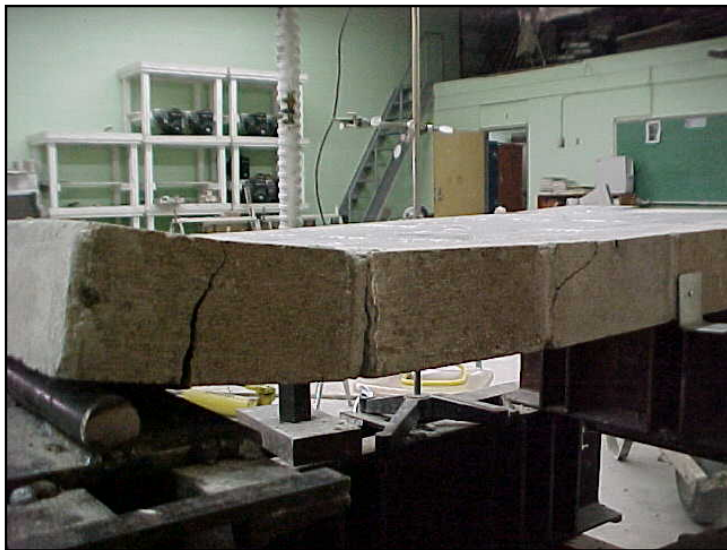
**Fig. 2.3.5j\*** *Developing of shear cracks for the entire length*

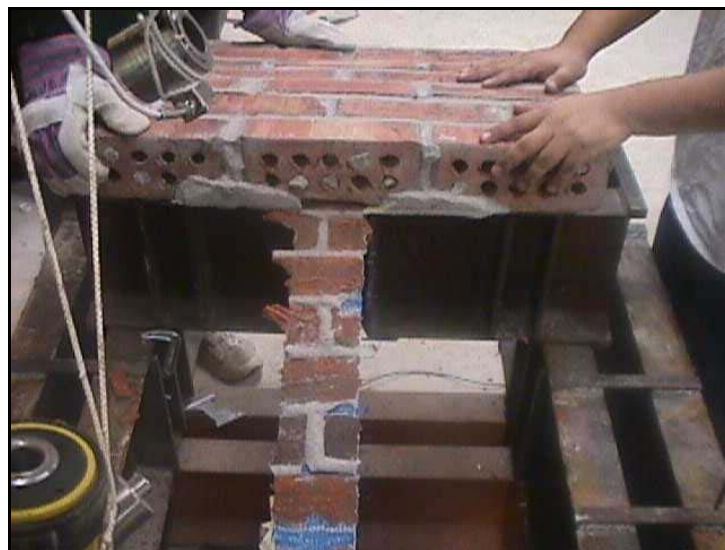
Fig. 2.3.5b\*\* Debonded FRP laminate after failure

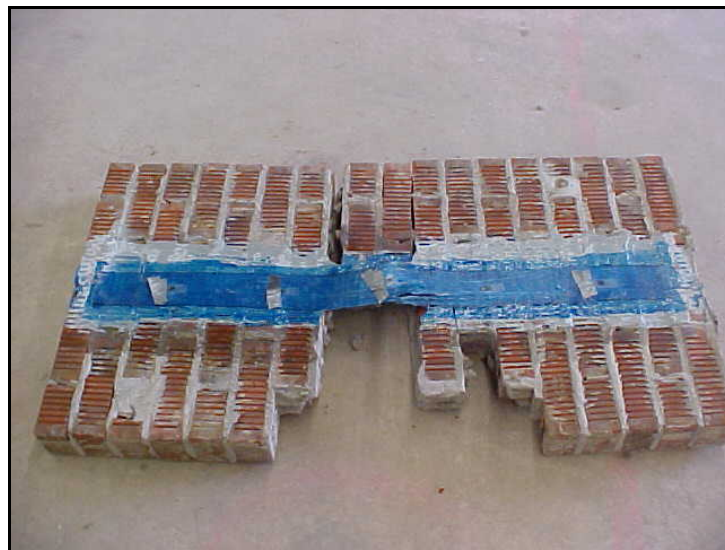
Fig. 2.3.5d\*\* *Rupture of GFRP laminate at mid-height*

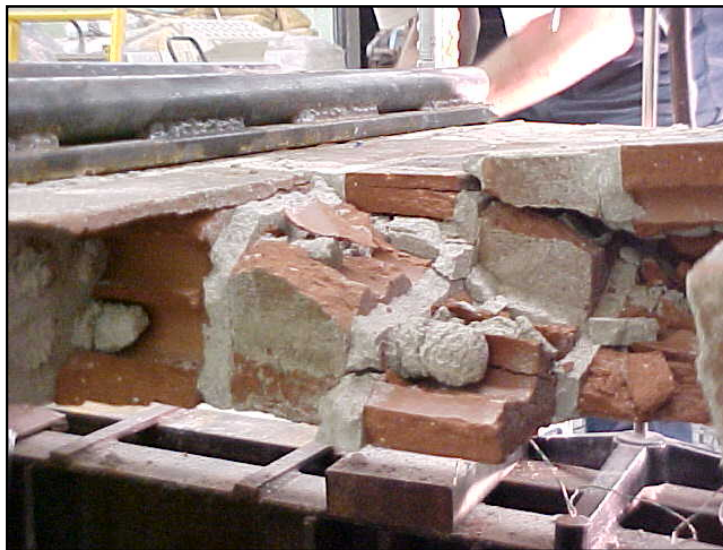
**Fig. 2.3.5l** *Shear failure with separation of masonry elements*

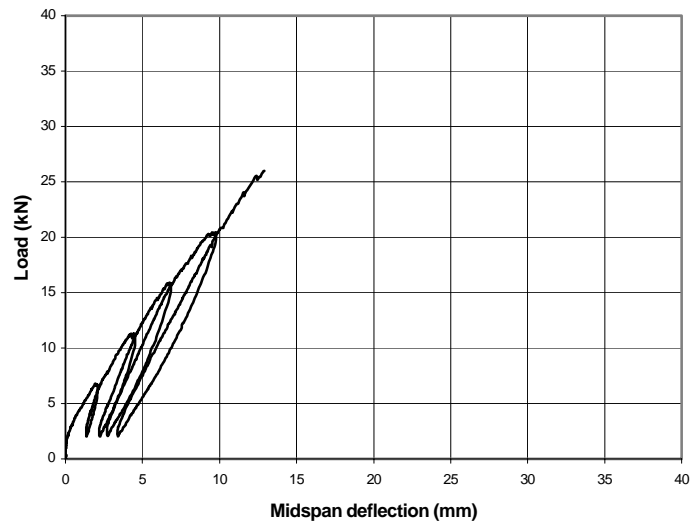
The most strengthened wall using GFRP laminates exhibited the same undesirable mode of failure observed for CLG9 (Fig. 2.3.5n\*\*). No differences were observed in terms of crack patterns up to failure. The wall revealed a significant stiff behavior during the load cycles, due to the largest amount of FRP reinforcement applied in this case. The peak load was reached at 26 kN for a midspan deflection of 13 mm.

**Fig. 2.3.5m\*\* Load vs. Midspan net deflection Curve, CLG12**

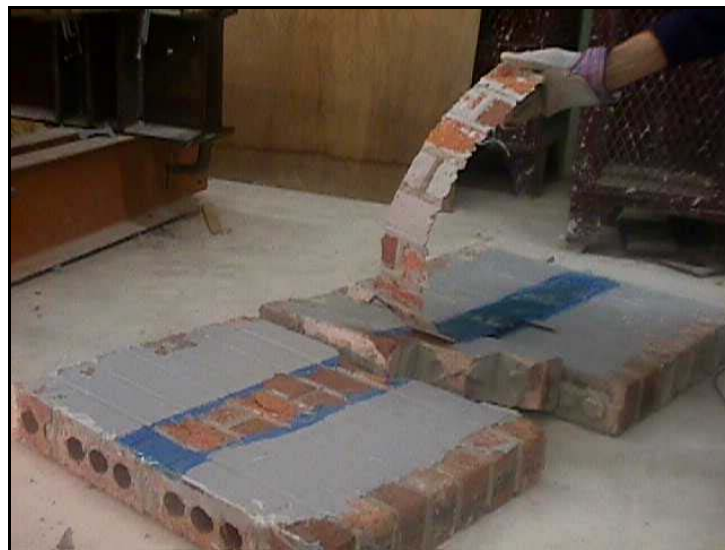
Fig. 2.3.5b\*\*\* *Debonded laminate after failure*

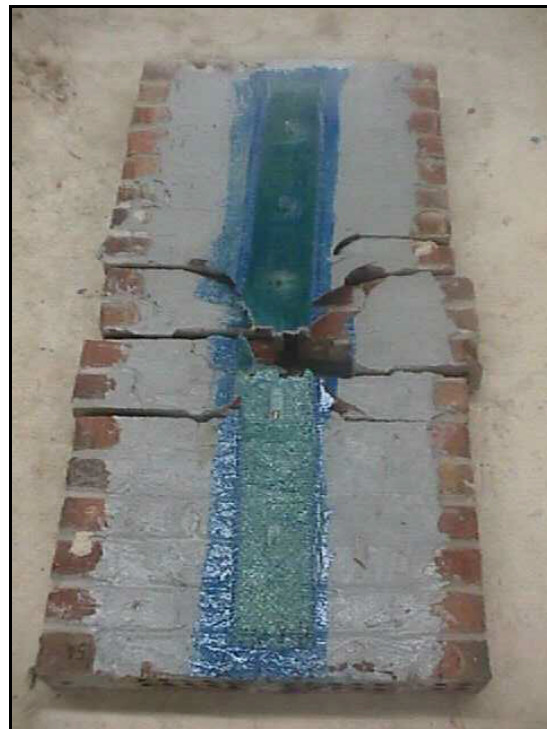
Fig. 2.3.5d\*\*\* Forming of the specimen after failure

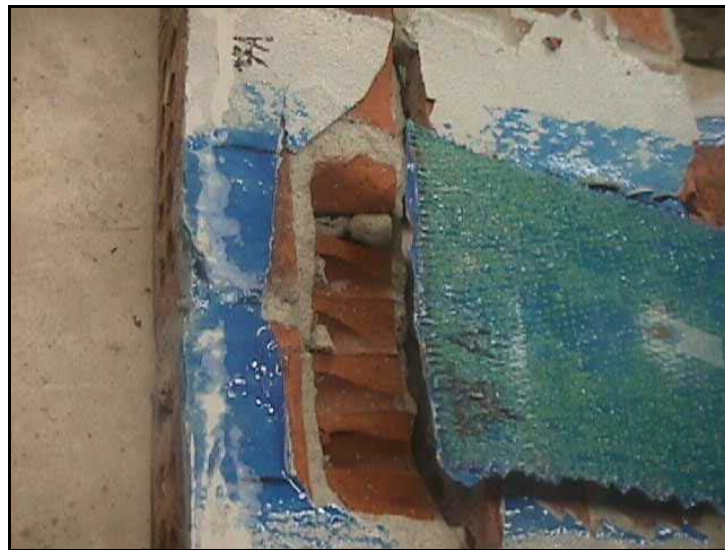
Fig. 2.3.5f\*\*\* Debonded laminate at the edge after failure

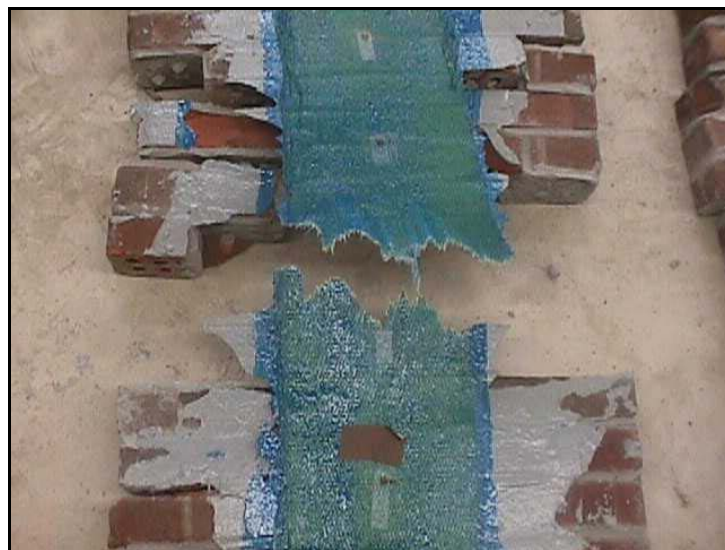
**Fig. 2.3.5h\*\*\*** Rupture of the AFRP laminate

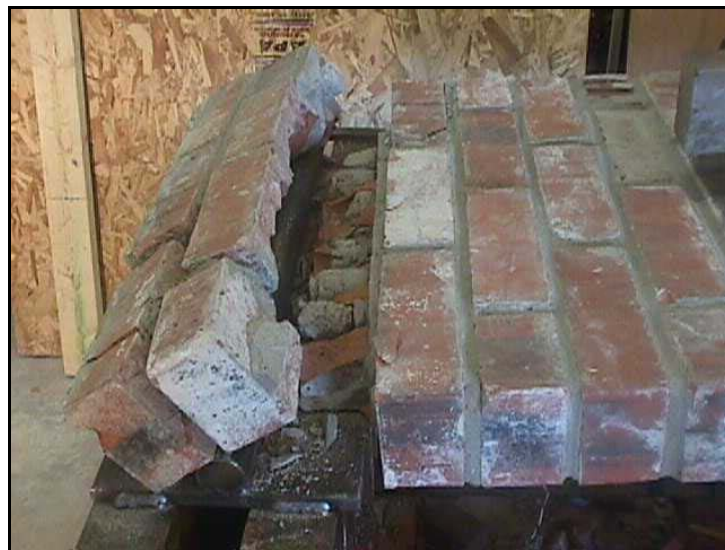
**Fig. 2.3.5j\*\*\*** Shear failure at the edge

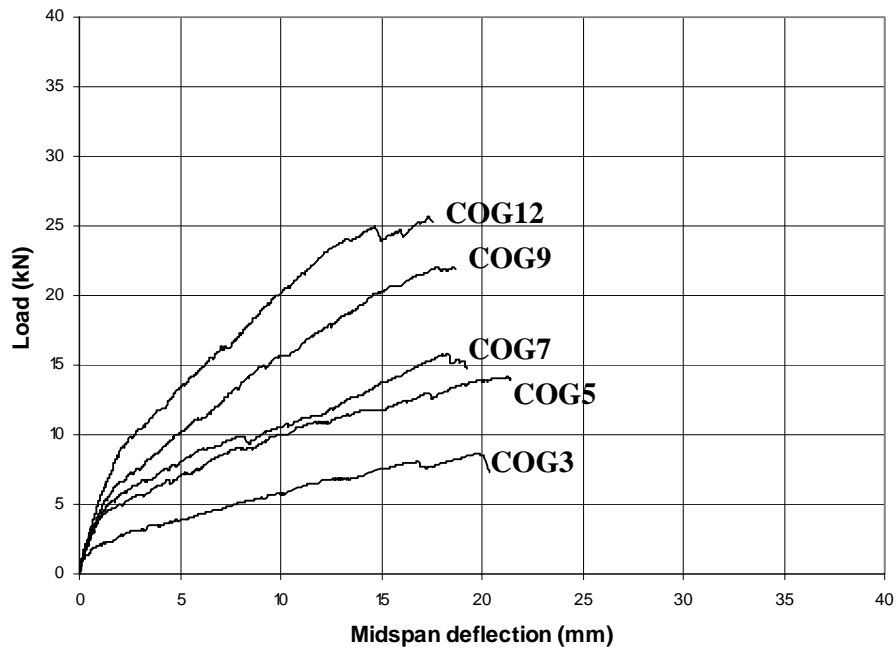
In Figure 2.3.6a-b the envelopes of load vs. midspan net deflection curves for concrete masonry specimens reinforced with GFRP and AFRP laminates respectively are presented. During the tests a malfunction to the Data Acquisition System occurred and caused the complete loss of the load-deflection trend for the specimen COA12.

Fig. 2.3.6a-b Envelopes of Series COG (top) and COA (bottom)

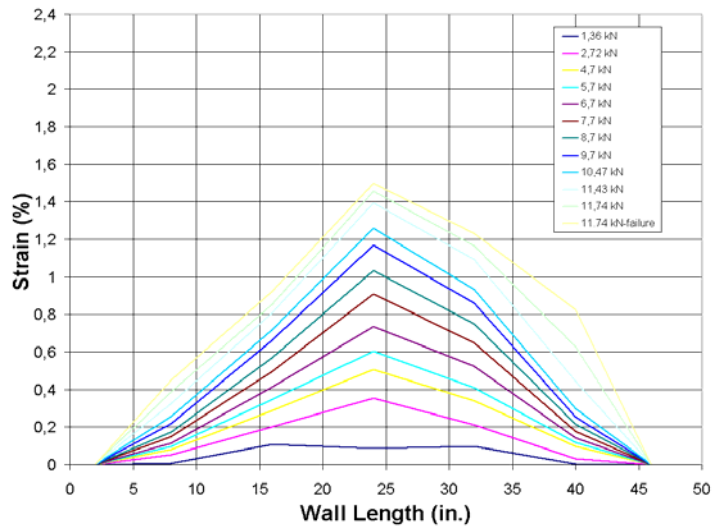
**Fig. 2.3.6a Tensile behavior of FRP reinforcement-COG3R**

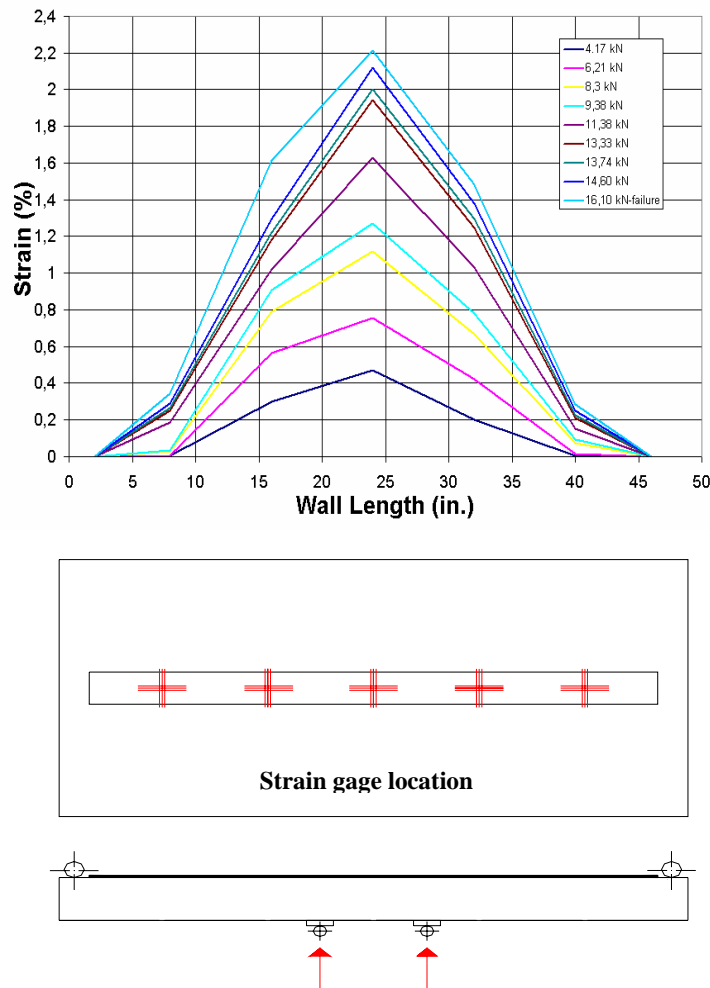
Fig. 2.3.6.1c presents the strain development along the FRP strip of CLG3R, which failed for rupture of the laminate at the final stage. Differently from COG3R and COG5R, the strain distribution exhibited a perfect symmetrical behavior up to failure, validating the experimental observations on the debonding phenomenon.

**Fig. 2.3.6.1c Tensile behavior of FRP reinforcement-CLG3R**

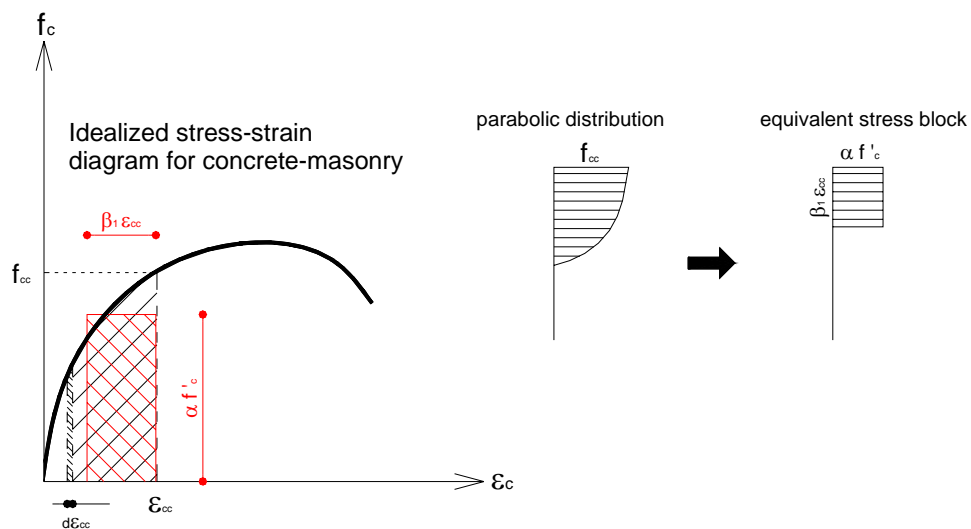
The stress-strain relationship of the fiber-reinforced composites systems is generally considered to be linear elastic up to failure, while the stress-strain behavior of the masonry is modeled based on the idealized uniform stress block, derived as shown in Fig. 2.3.7a. According to the diagram presented below, the coefficients  $\alpha$  and  $\beta_1$  should be calculated using the following equations.

Fig. 2.3.7a Stress block derivation

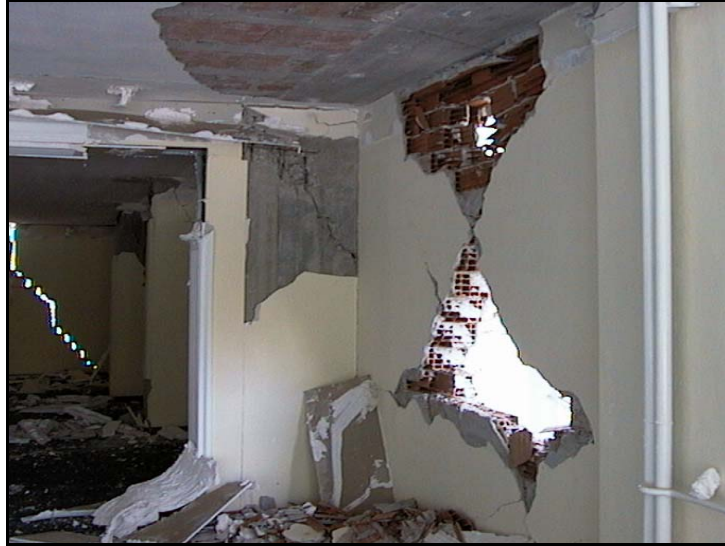
**Fig. 3.1b** *Diagonal tension failure (Turkey 1999)*

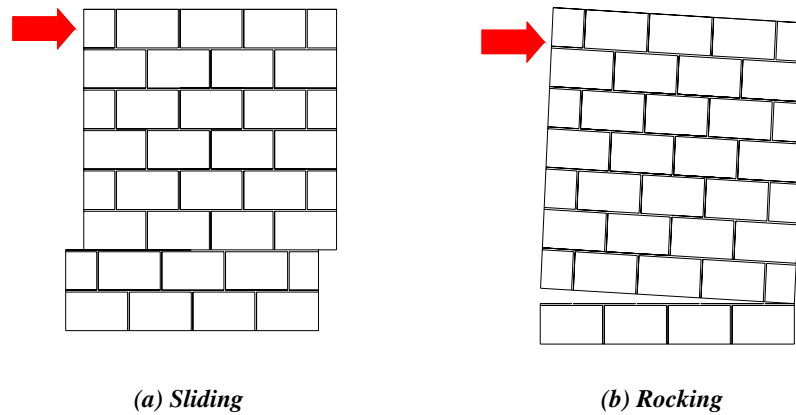
failure may be observed. One is *sliding* of the wall along the bed joints (Fig. 3.1d); the other is *rocking* on a horizontal crack at the wall bottom (see Fig. 3.1e). The overall stability of the building is not compromised as long as the deformation are small. If the masonry wall bears high axial loads, the bed joint friction is increased and therefore sliding or rocking will not be observed. Instead, diagonal shear crack will be developed.

**Fig. 3.1d** Potential failures in walls with no axial load: *Sliding (a) and Rocking (b)*

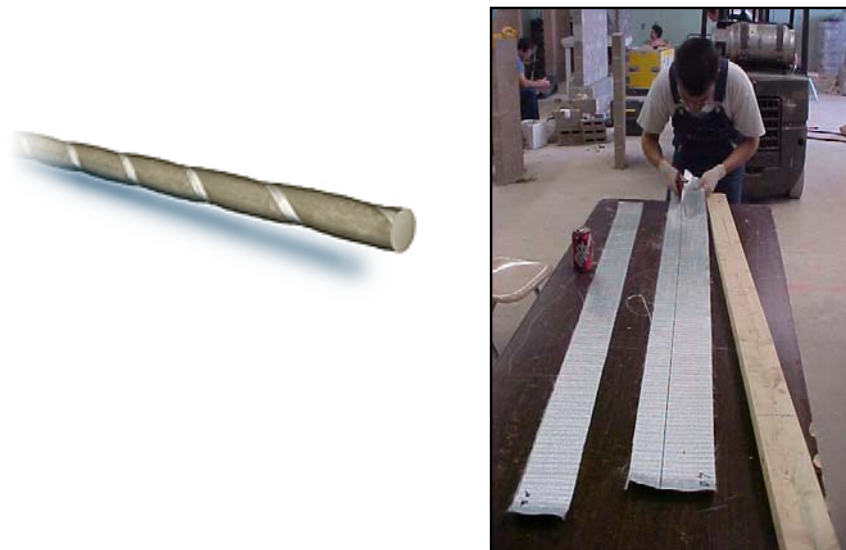
**Fig. 3.1e** *GFRP rod (left) and laminates (right)*

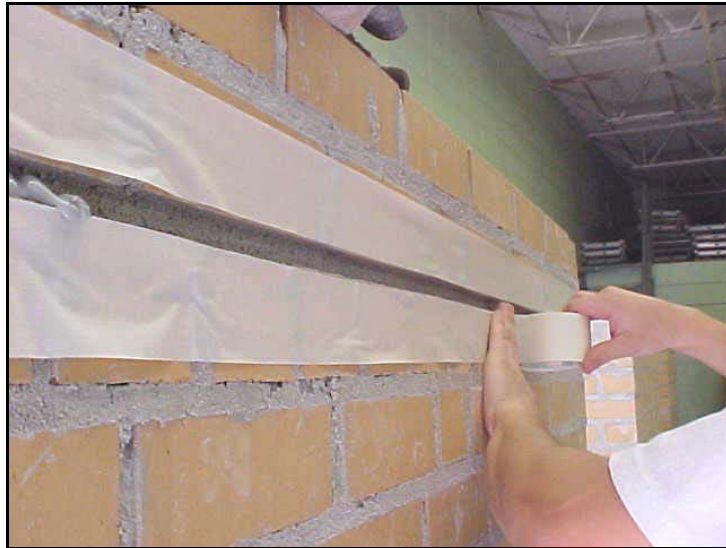
**Fig. 3.3.4d** *Masking of masonry to avoid staining*

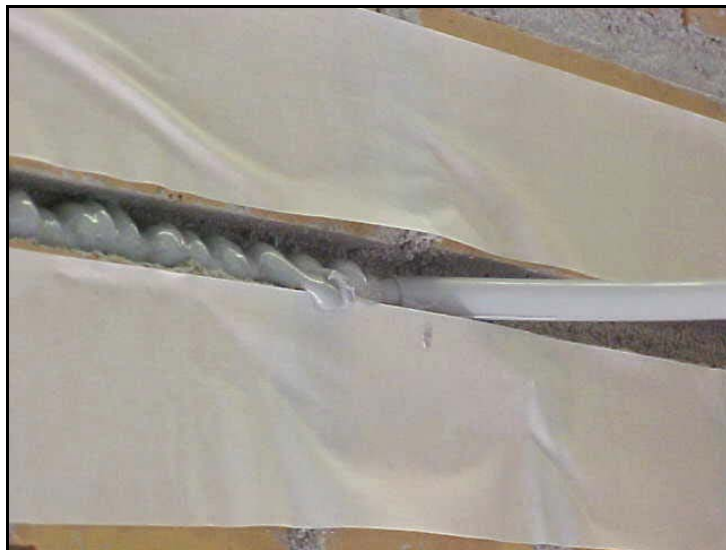
**Fig. 3.3.4e** *Injection of epoxy-based paste into the groove*

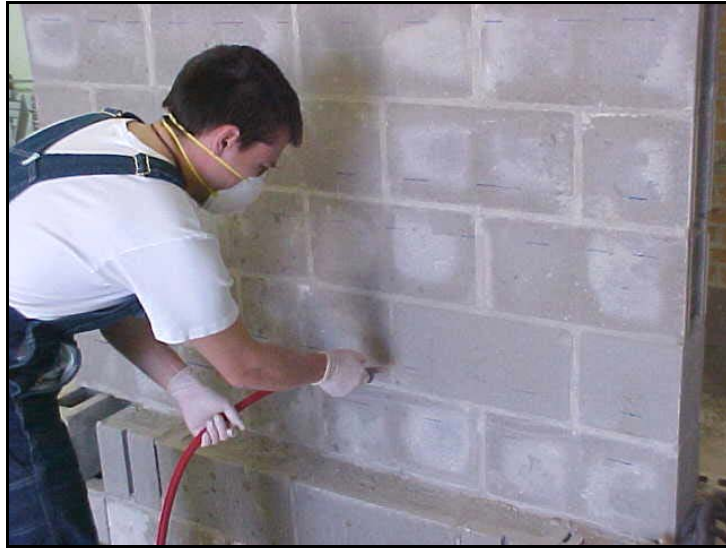
**Fig.3.3.4j** *Removal of any loose parts from the masonry surface*

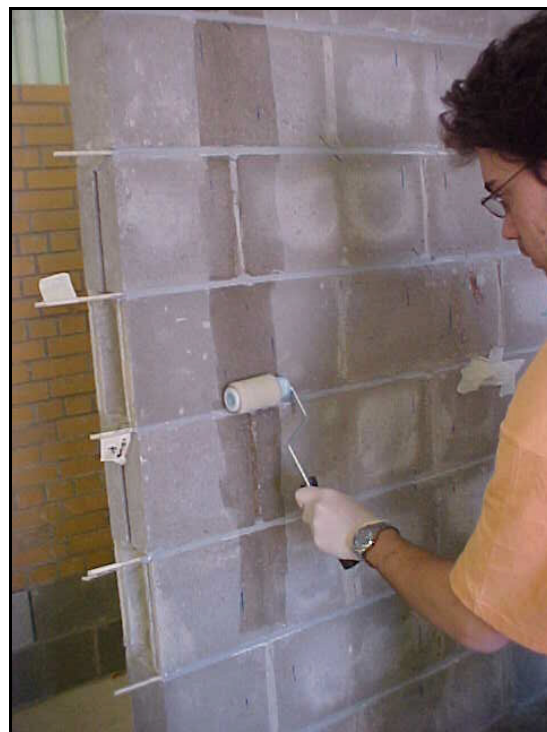
**Fig. 3.3.4k** *Primer application*

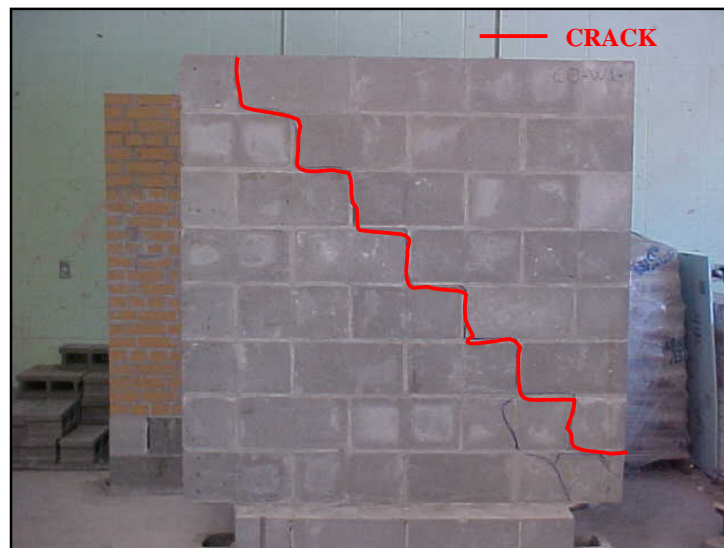
Fig. 3.5.1b Developed crack along the diagonal mortar joints

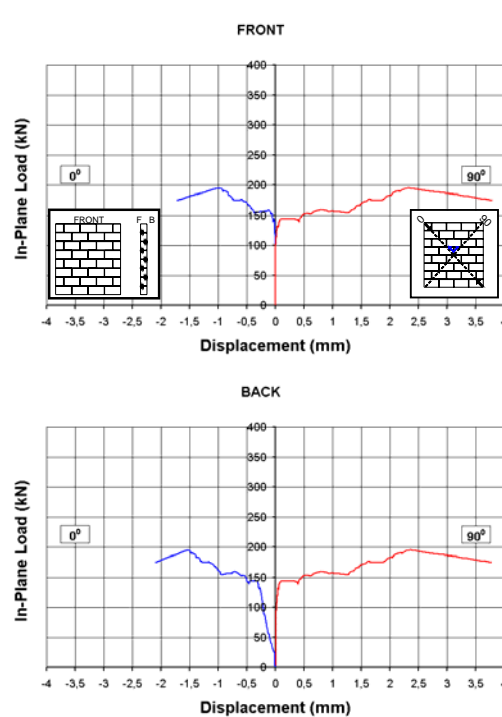
Even if the ultimate shear capacity was the same of COW2, as observed in Fig. 3.5.1e, the panel exhibited at the ultimate stage more stability than COW2, due to the symmetrical configuration of the reinforcement, which led to similar crack openings on the two faces of the wall.

Fig. 3.5.1e Load vs. Diagonal Displacement Curves-COW3

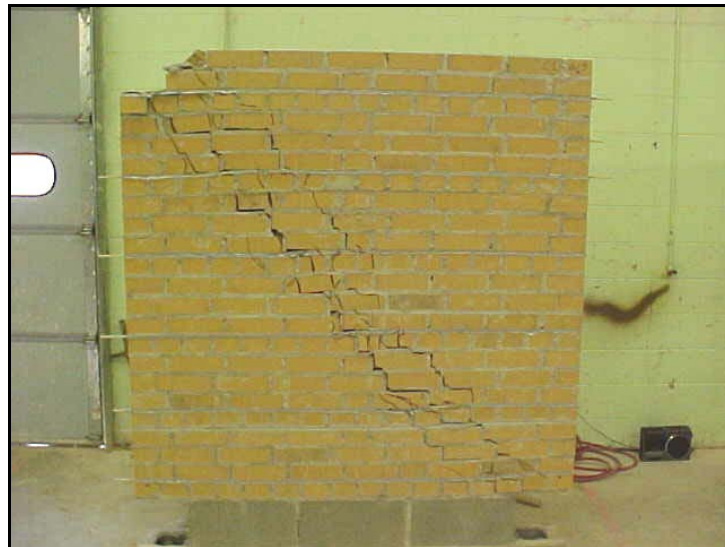
**Fig. 3.5.2h** Crack pattern of CLW4

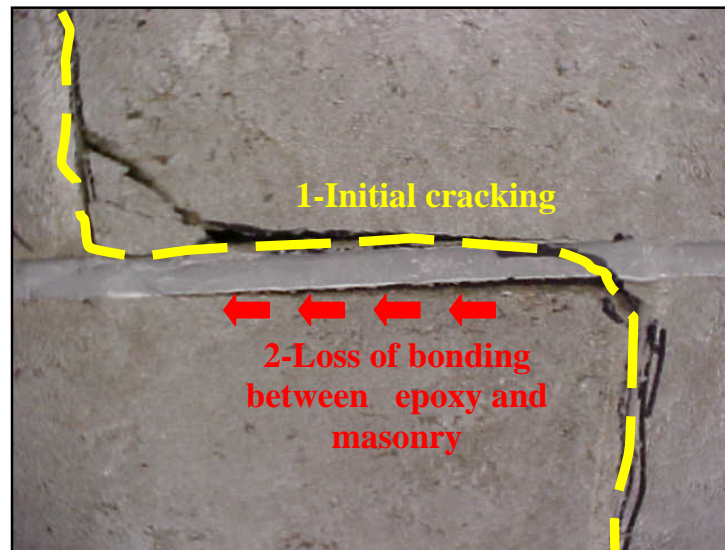
- **In-Plane Phase:** When the tensile strength of masonry is overcome, the wall cracks along the diagonal, following the mortar joints (stepped crack vertical/horizontal, see Fig.3.5.3.1a) For the reinforcement placed in the horizontal joint, the crack is typically at the top side (see item 1 – Fig. 3.5.3.1a). Wall failure occurs only when a second crack develops below the reinforcement at the epoxy/block interface (see item 2 – Fig. 3.5.3.1a)

Fig. 3.5.3.1a *In-Plane failure component*

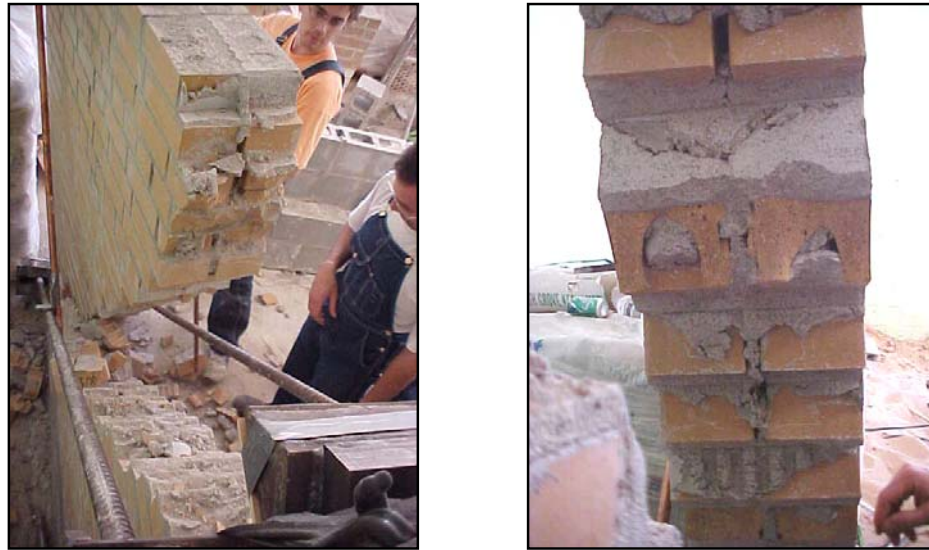
Fig. 3.5.3.2a(left)-b(right) *Splitting of clay units in CLW1*

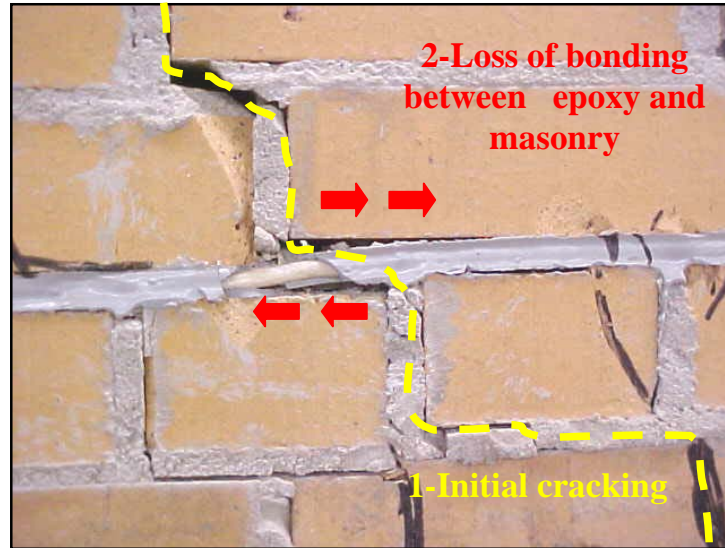
Fig. 3.5.3.2c *Horizontal component*

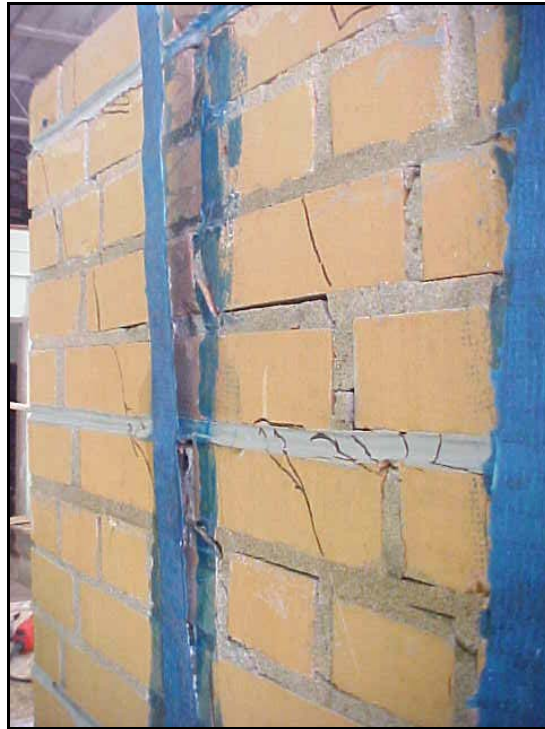
**Fig. 3.5.3.2d** *Delamination of GFRP laminates from clay surface*

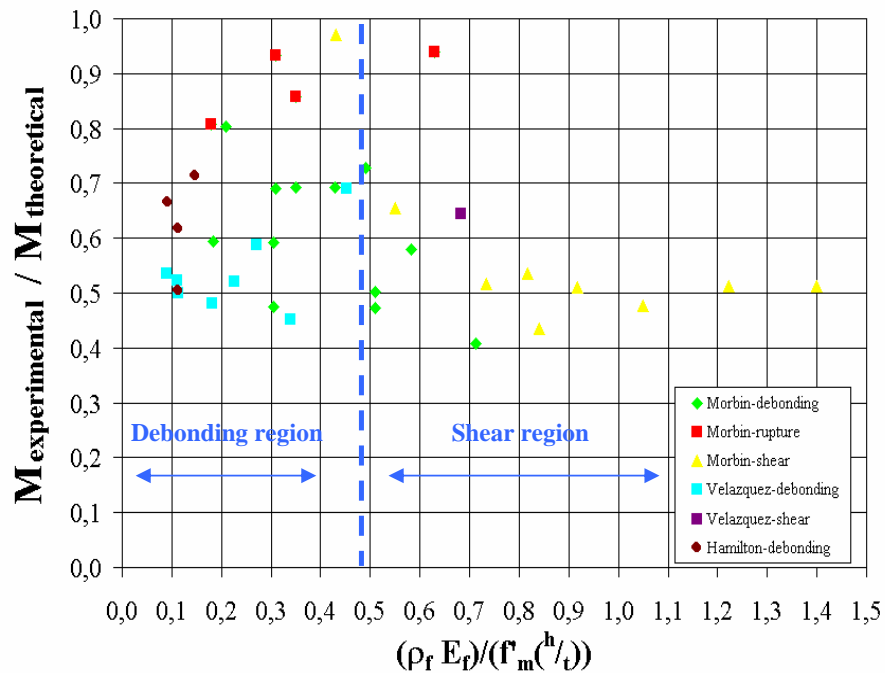
Fig. 4.1a Influence of amount of FRP reinforcement

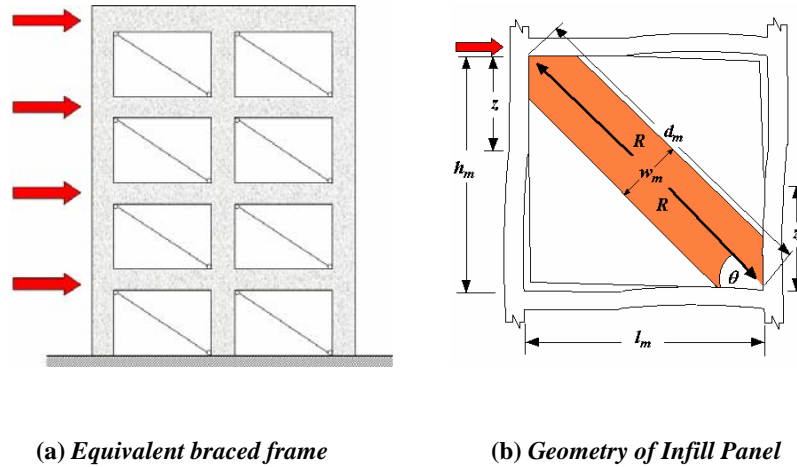
(a) Equivalent braced frame
