# CENTER FOR INFRASTRUCTURE ENGINEERING STUDIES

## Strengthening of Masonry Elements with FRP Composites

*University of Missouri-Rolla*  
Antonio Morbin, Visiting Scholar

**CIES**  
**02-23**

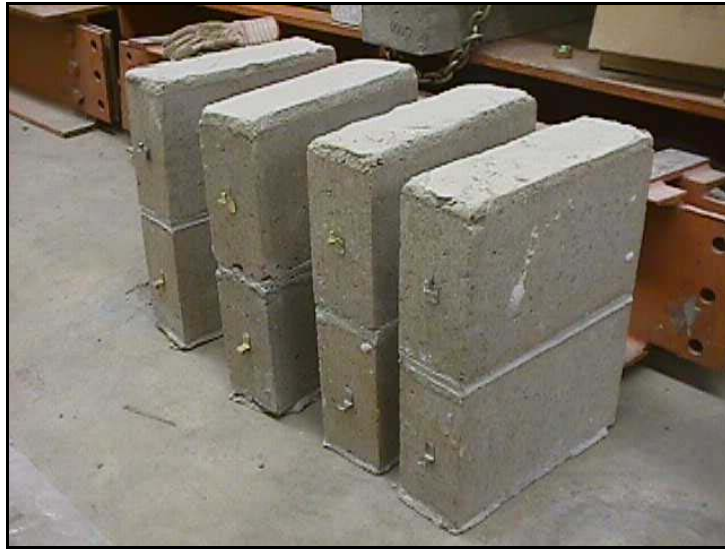
**Fig. A.1.1b Concrete prisms in lab environment**

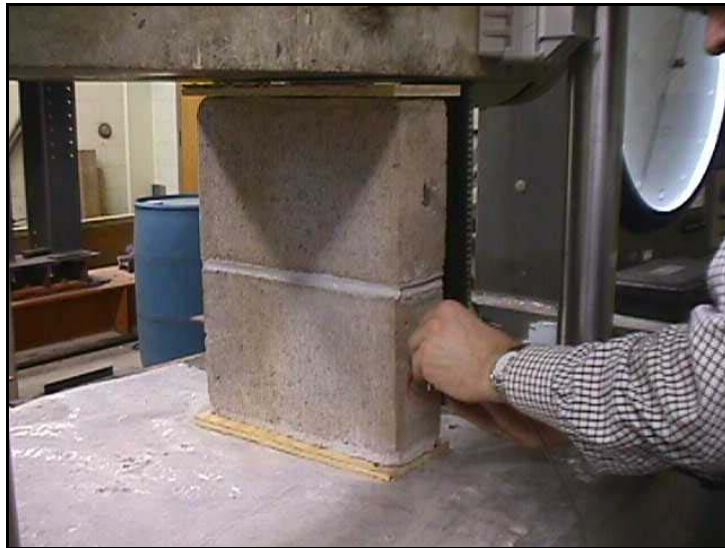
**Fig. A.1.1c Test preparation**

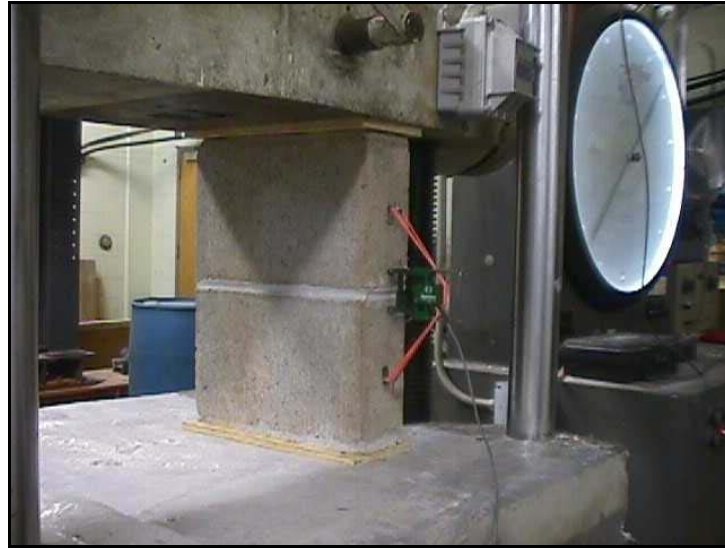
**Fig. A.1.1c** Test setup

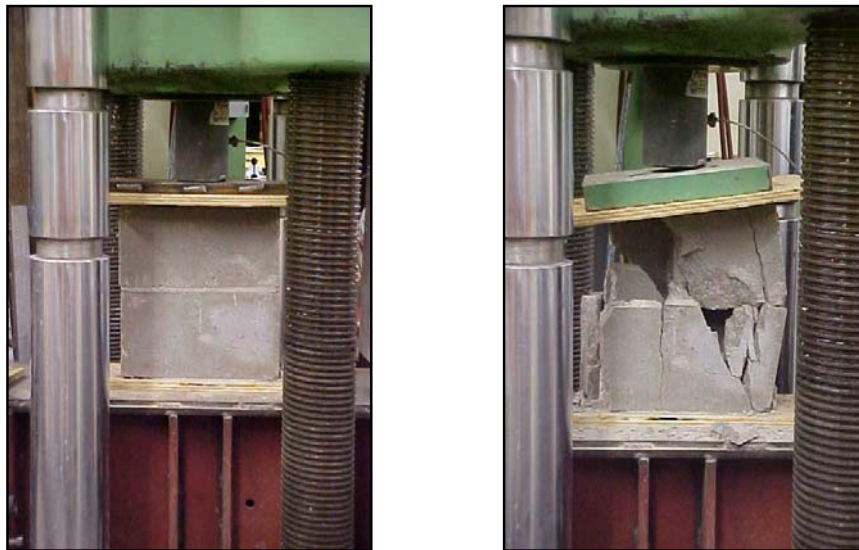
**Fig. A.1.2b-c Compression test: prism before (left) and after (right) failure**

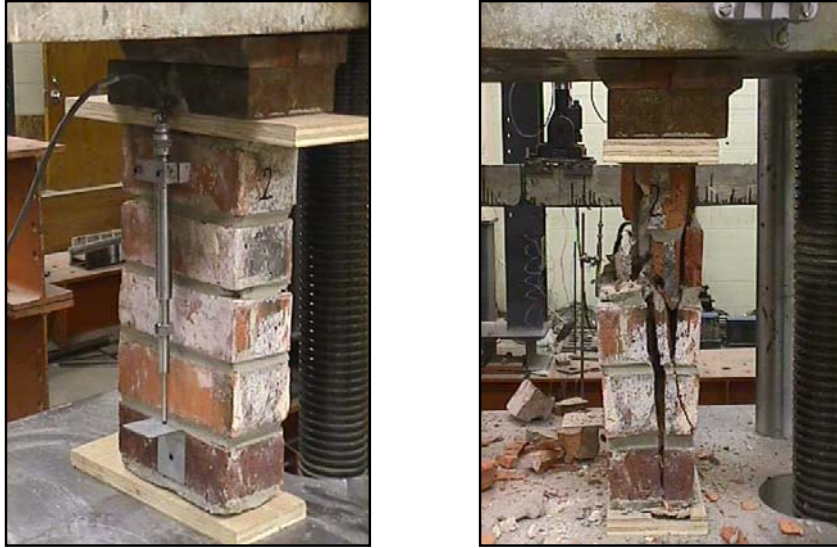
Fig. A.2.1b-c Dark clay prism before (left) and after failure (right)

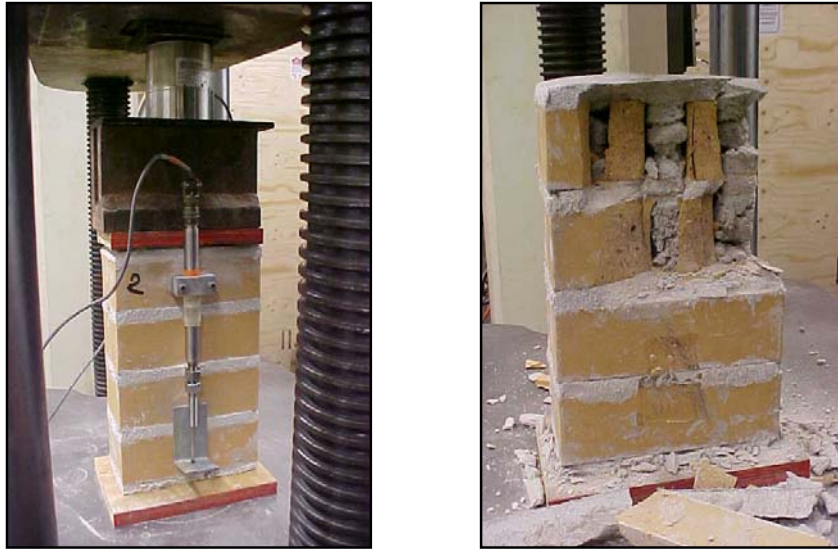
**Fig. A.2.1d-e** *Light clay prisms before (left) and after (right) failure*

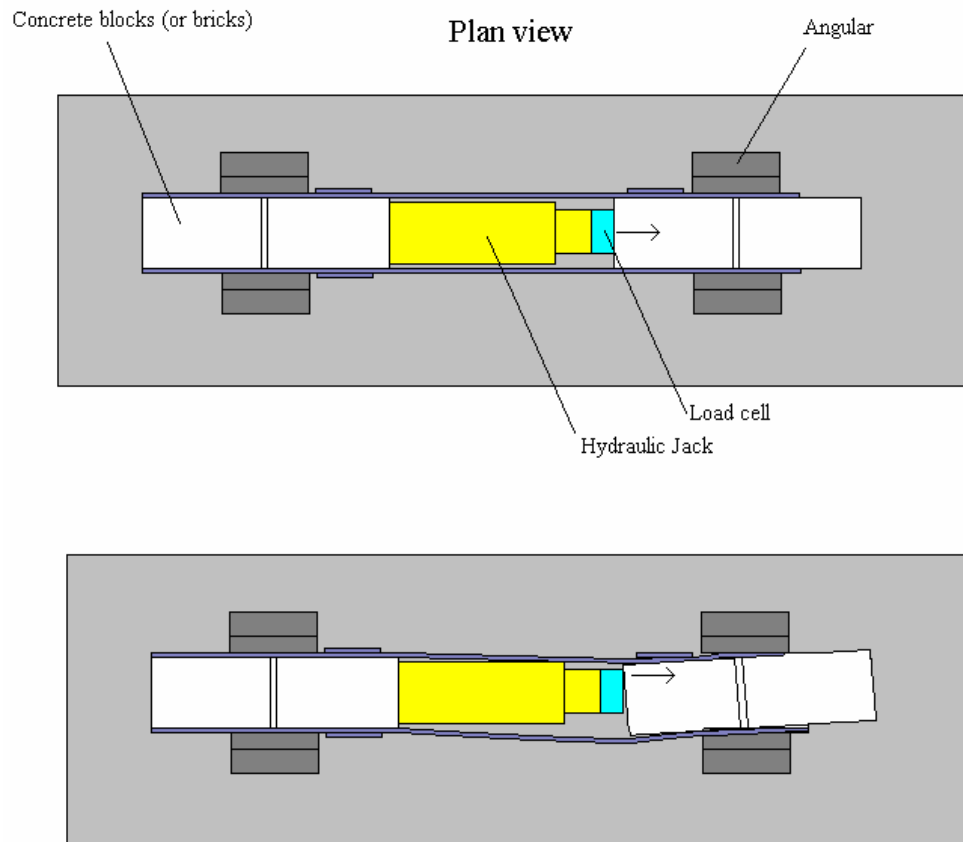
**Fig. A.5.4a Cause of failure in tests CA3-12 and BA3-12**

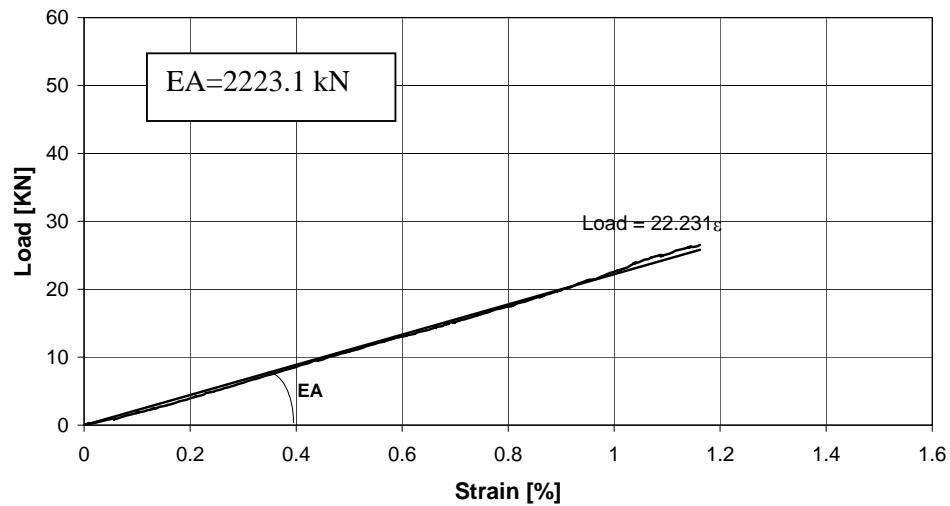
Fig. A.5.5a Axial stiffness for CA3-8

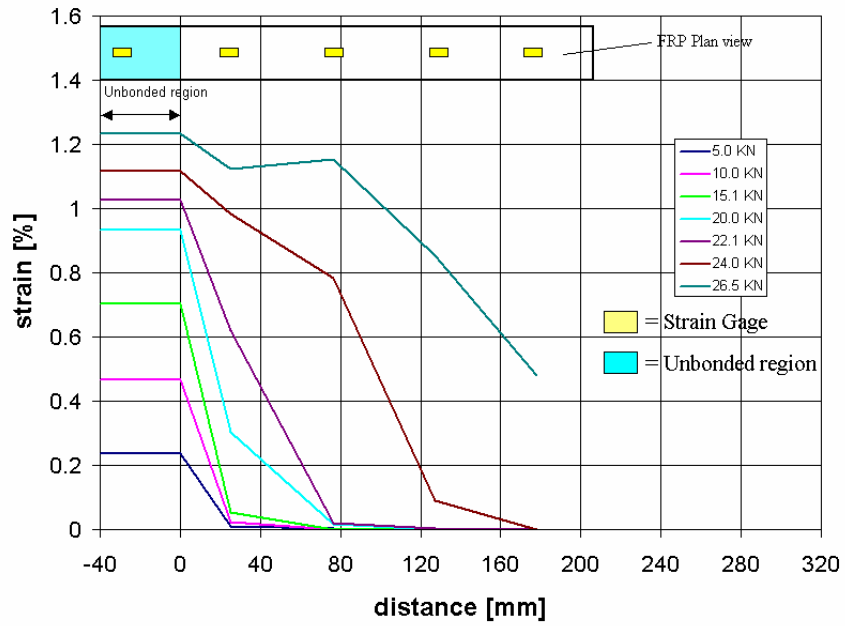
Fig. A.5.5b Typical strain vs. location graph for concrete blocks (specimen CA3-8)

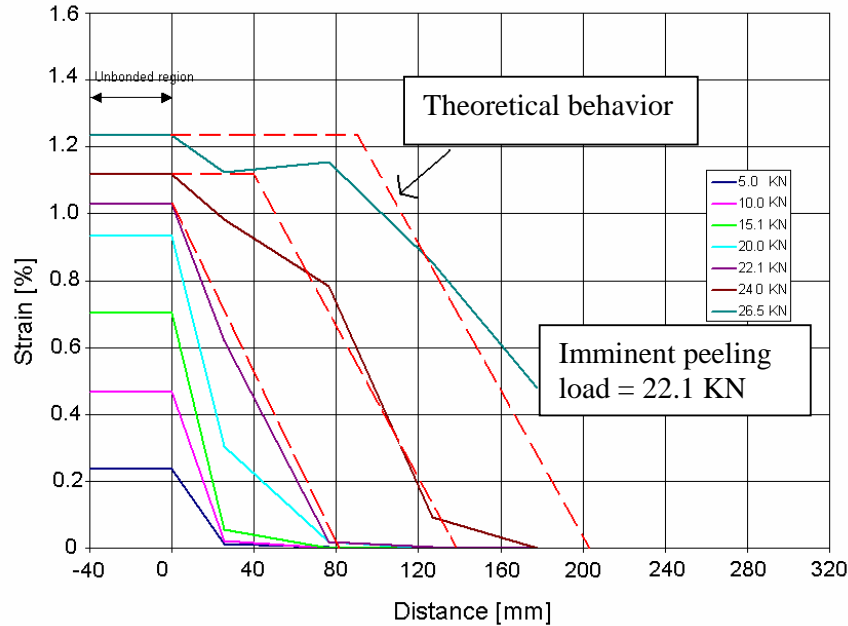
Fig. A.5.5e Determination of imminent peeling load for specimen CA3-8

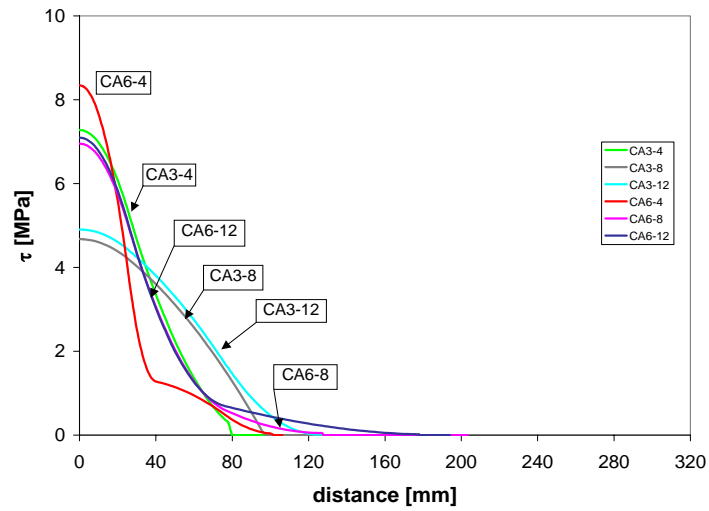
**Fig. A.5.6f Comparison among the experimental results in terms of  $\tau$  vs. location for the concrete blocks**
